## Reducing Fracture Tendencies in PCBN FSW Tools

ONR Contract Number N00014-09-C-0288

### **Semi Annual Report No. 1**

Period: February 3, 2009 through July 31, 2009

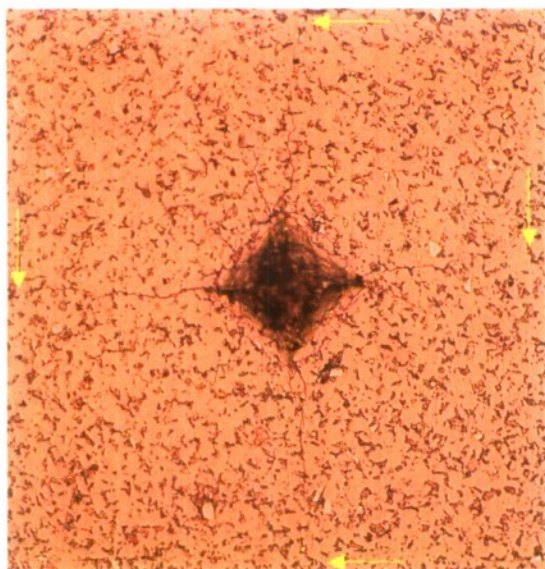
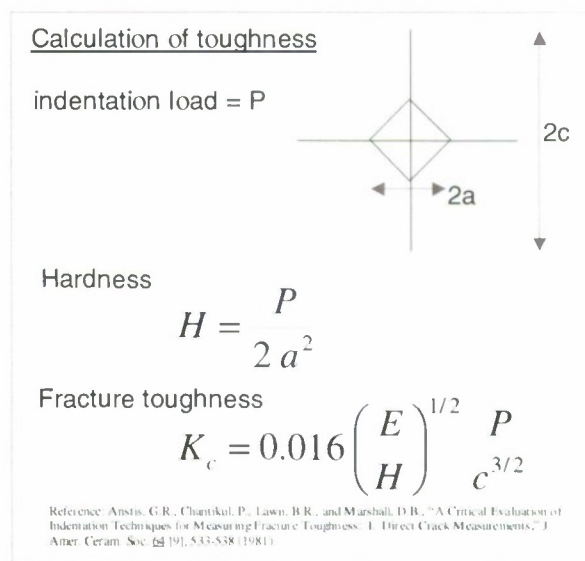
Fig. 1. Indentation method for measurement of fracture toughness: (a) Vickers indentation (200N load) in polished surface of polycrystalline cubic BN (MS80). Arrows indicate positions of crack tips, which can be readily located in higher magnification optical micrographs; (b) Schematic of indentation and cracks, with fracture mechanics expression from which the fracture toughness can be evaluated.

The fracture toughnesses of the three MS80 materials described above were measured by indentation fracture. The method, which is summarized in Fig. 1, involves loading a Vickers diamond indenter on a

polished surface, generating a contact zone of plastic deformation (from which the hardness can be evaluated) and two half-penny cracks centered on the indentation and aligned normal to the surface along the indentation diagonals. A fracture mechanics analysis of the formation of these cracks gives the expression in Fig. 1b, which is valid if the cracks are sufficiently large compared with the contact zone. This expression can be used to evaluate the fracture toughness from the measured crack lengths.

This technique has been developed extensively with ceramic materials, although it has not been applied previously to PCBN materials. Indentations in PCBN at loads smaller than ~50 N generally produce irregular crack patterns because of their high hardness and relatively large grain size. However, at higher loads well developed cracks are produced, as in Fig. 1.

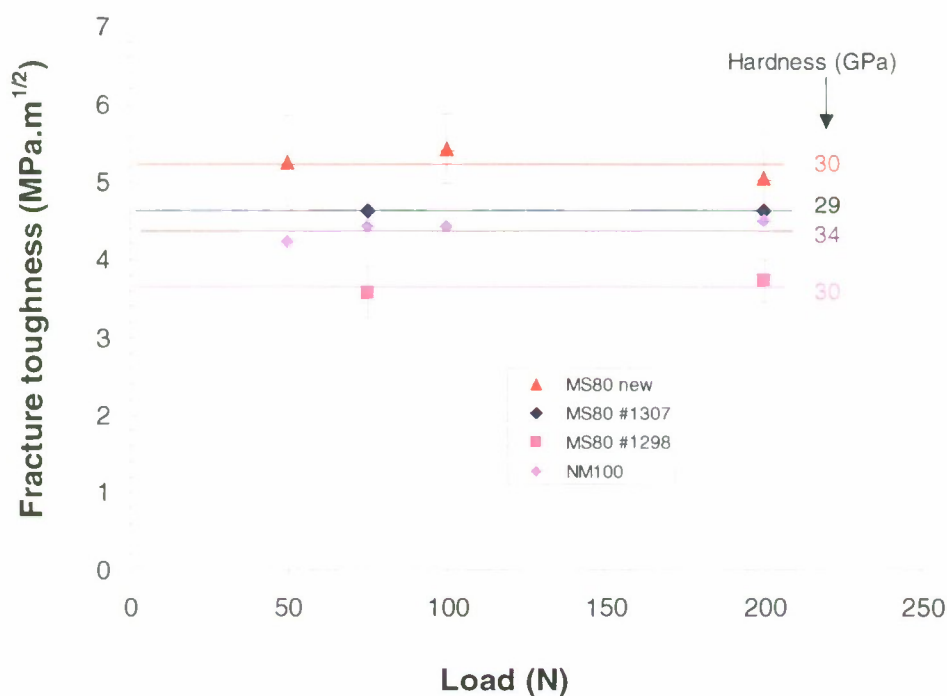
Fig. 2. Indentation fracture toughness measurements from several PCBN materials. Error bars indicate standard deviations.

The results of toughness measurements from the three MS80 materials are summarized in Fig. 2. Also shown are measurements from another PCBN material (MN100) which has much higher volume fraction of BN and smaller amount of grain boundary phase (AlN). For each material the toughness was evaluated from indentations at several different loads within the range 50 to 200 N, with each data point being an average of at least 10 measurements. The observation in Fig. 2 that, in all cases, the toughness is

independent of the indentation load confirms the functional form of the toughness equation and thus the validity of the underlying fracture mechanics analysis.

Significant differences are evident in the fracture toughnesses of the three MS80 materials. The highest toughness ( $5.2 \text{ MPa}\cdot\text{m}^{1/2}$ ) is observed in the new material which was also much more difficult to grind and polish than the other two materials. However, the relative ranking for the other two materials is opposite to their relative performance in FSW: the material with lower toughness (#1298) is the one with the longer FSW life. Further measurements will be made to investigate whether this trend is followed in other materials.

The hardness of these materials is expected to scale with the volume fraction of BN and be relatively insensitive to subtle microstructural variations that influence fracture toughness. The measured hardnesses listed in Fig. 2 are consistent with this expectation: the values for the three MS80 materials are indistinguishable (30 GPa) whereas the value for the MN100 material is higher (34 GPa).

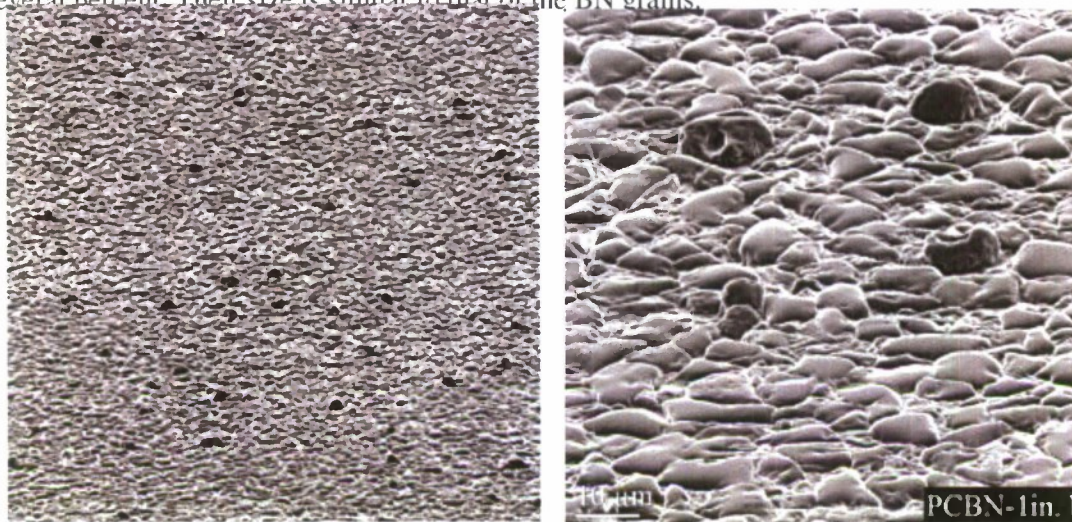
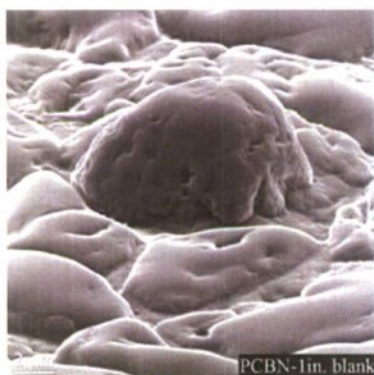
*Fig. 3 SEM micrographs of new MS80 material showing surface after polishing with diamond impregnated cloth which produced relief of diamond particles (same area at three different magnifications). Dark grains in (a) are diamond*

The new MS80 material was much more difficult to cut and polish than other PCBN materials. After initial attempts to polish the surface of this material using a relatively soft cloth that produced a good polish on other PCBN materials, we found that strong relief was produced, with some grains remaining raised significantly above the majority of grains (Fig. 3). EDS analysis indicated that these grains were

carbon. Analysis by Raman microprobe spectroscopy confirmed that the grains are diamond. The diamond grains were distributed very uniformly throughout the material, with a volume fraction of several percent. Their size is similar to that of the BN grains.

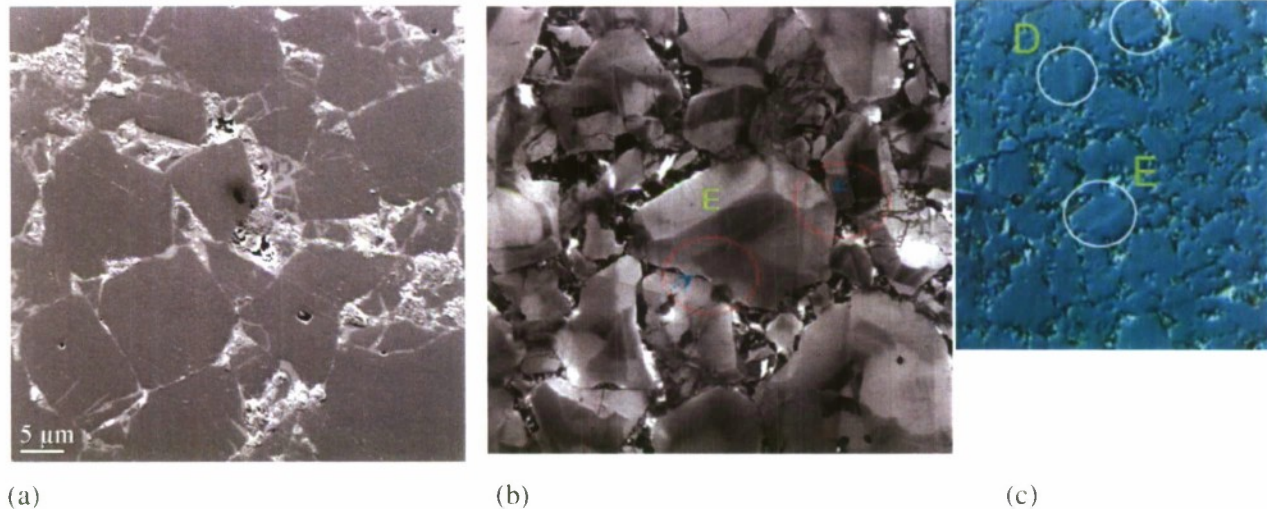
*Fig. 4. Polished surface of MN100 material: (a) SEM image from surface coated with conducting layer of gold; (b) SEM image from uncoated surface (micrograph from Qingyuan Liu, Megadiamond); (c) Nomarski interference micrograph from area in (b), showing surface relief features in some grains.*

In the course of SEM examination of these materials we discovered (in collaboration with Megadiamond) an imaging method that reveals internal crystallographic structures in BN grains, which are not normally detectable by SEM. An example is shown in Fig 4. When imaged with secondary electrons, with a thin conducting layer of gold deposited on the surface to prevent charging (the usual procedure for insulating materials), the BN grains are featureless and the AlN grain boundary phase shows lighter contrast (Fig.

4a). Similar contrast is seen in backscattered electron images (Fig. 5). However, when imaged with secondary electrons without a conducting layer on the surface, dramatically different contrast is observed (Fig. 4b): crystallographic features resembling twins are clearly evident, more contrast detail is visible within the grain boundary phases, and there is a general reversal of contrast between the grains and the grain boundary phase (the BN grains being lighter than the grain boundary phase). In many grains, there is a one-to-one correspondence between these crystallographic features and lines of surface relief visible by Nomarski interference (Fig. 4c). The surface relief may result from different polishing rates in regions of different crystallographic orientations.

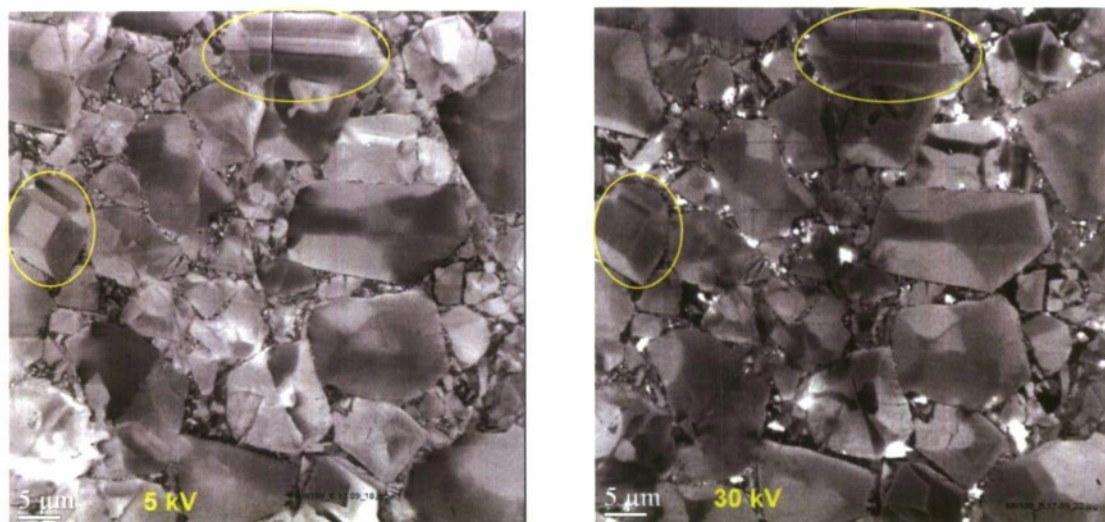
*Fig. 5. Reversal of contrast in secondary electron images from uncoated surface of MN100 material at two different accelerating voltages: (a) 5 KV; (b) 30 KV.*

The detailed contrast in images such as Fig. 4b was found to be sensitive to the accelerating voltage, with reversals of contrast occurring within some grains when the voltage was changed (Fig. 5). This and the observation that the contrast within the BN grains disappears when surface is coated with conducting gold suggests that contrast may be associated with charging. (The image contrast also disappears when the surface is coated with carbon, Fig. 6, thus eliminating the possibility that the contrast is obscured by scattered electrons from the gold coating.)

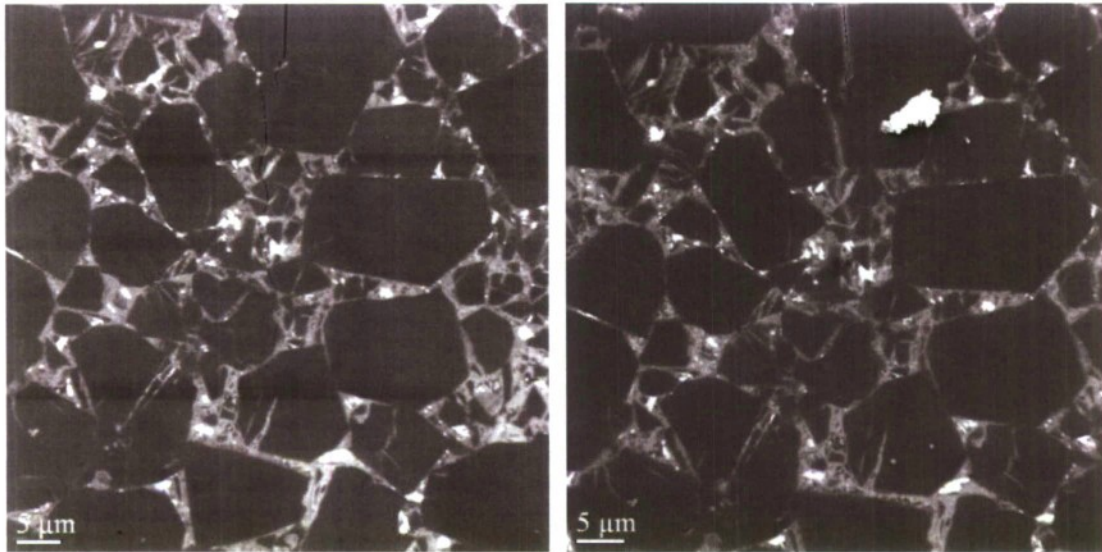
*Fig. 6. Images from area of Fig. 5: (a) backscattered electron image, uncoated surface; (b) secondary electron image after coating the surface with carbon.*

We hypothesize that these contrast features may correspond to internal twins or other deformation structures in BN grains, possibly caused local contact forces due to grain-to-grain contact during high pressure consolidation. Similar contrast features are observed in the MS80 materials, although only a small fraction of grains show internal features (consistent with expectation that, with the higher binder content, less damage occurs in MS80 from neighboring grains being in direct contact during densification).
